# **City Of Stevenson Street Tree Inventory and Management Plan**

The City of Stevenson, Washington
March 2, 2022

**Urban Forestry Services | Bartlett Consulting**

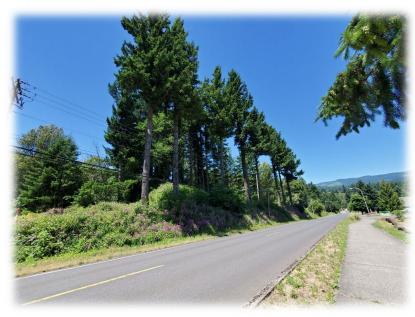
Photo 2. Tree #346-356 could have been identified and managed as a single group. This row of young Douglas fir all about the same size and age were all recently heavily pruned for power line clearance.

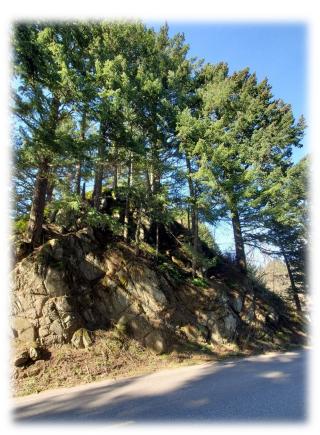
Photo 3. Trees 299-308 should be managed individually and not as a group. Trees along this rock face next to the power lines are different sizes and will likely require different management goals in the future.

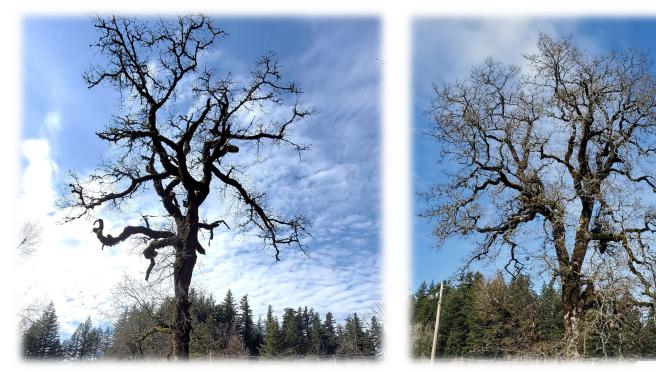
Photo 8, 9. These two mature, large Garry oak trees have different condition classes. The tree on the left is in poor condition with very few small branches, and a thin poorly distributed canopy. The tree on the right is likely the same age, however it has many new small branches and is in better overall condition.

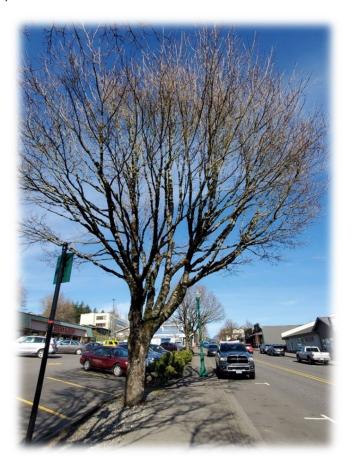
Photo 12. Tree #114, a Norway Maple, is recommended for an ISA Level 2 Basic Assessment due to defects observed and potential targets surrounding the tree.

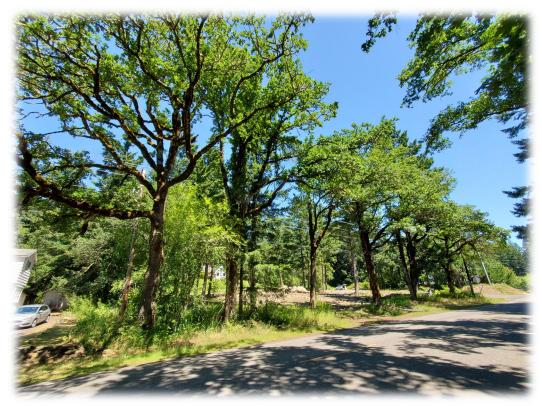
Photo 13. Trees 299-307 were impacted by private property construction. These trees are large and target power lines, the road and future private structures. The level 1 visual risk assessment did not indicate these trees are a high risk, however these trees should have a Level 2 Basic Assessment conducted.

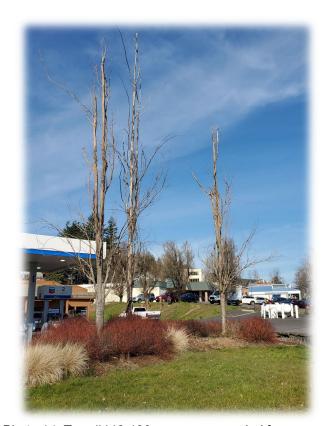
Photo 14. Tree #118-120 are recommended for removal

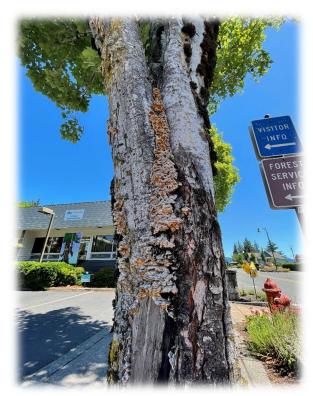
Photo 15. Tree # 100, a Freemans maple is recommended for removal due to extensive trunk and branch injuries, poor structure, the significant presence of wood decay fungi and the higher risk the tree poses to surrounding targets.

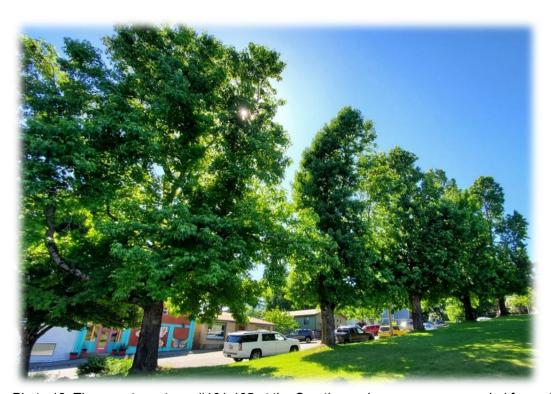
Photo 18. The sweetgum trees #161-165 at the Courthouse lawn are recommended for root invigoration and other soil treatments to promote and maintain good health and vigor for these important and valuable trees.

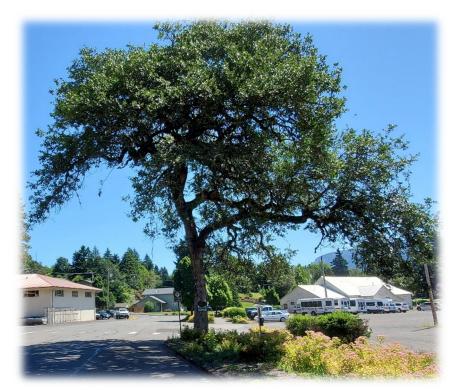
Photo 19. This white oak #201 has a recommendation to reduce risk of branch failure through end weight reduction. The tree is in a large growing space with compacted soil and would benefit from root invigoration and mulch.

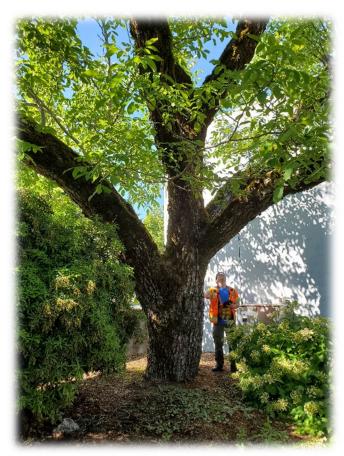
Photo 25. The Walnut tree #166 has a buried root collar. Excavation and assessment are recommended before propping the tree.

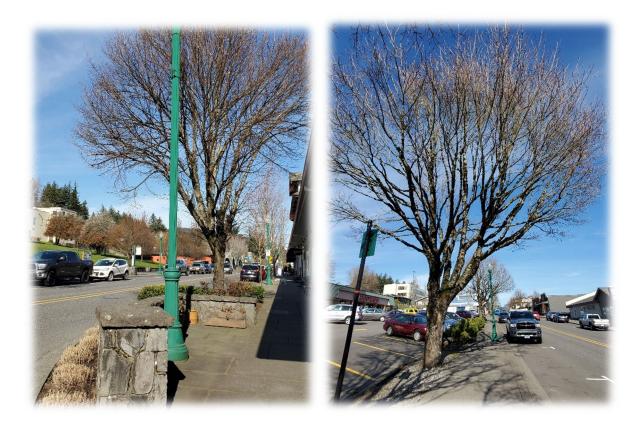
Photo36, 37. Tree #98 and 114 are mature and cannot be easily pruned for correction. Both canopies can be cabled to prevent future snow, ice and storm damage.
