Stevenson Fire Department

Needs Assessment

May 2019

City of Stevenson New Fire Station

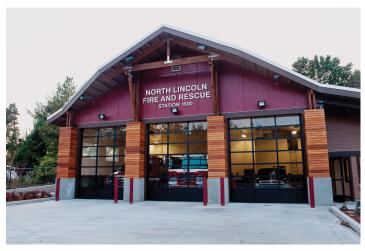
North Lincoln Fire and Rescue Delake Station MACKENZIE

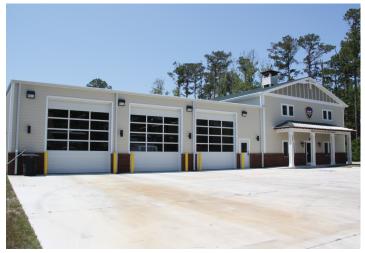
Roanoke Island Fire Department PREMIERE CONTRACTING

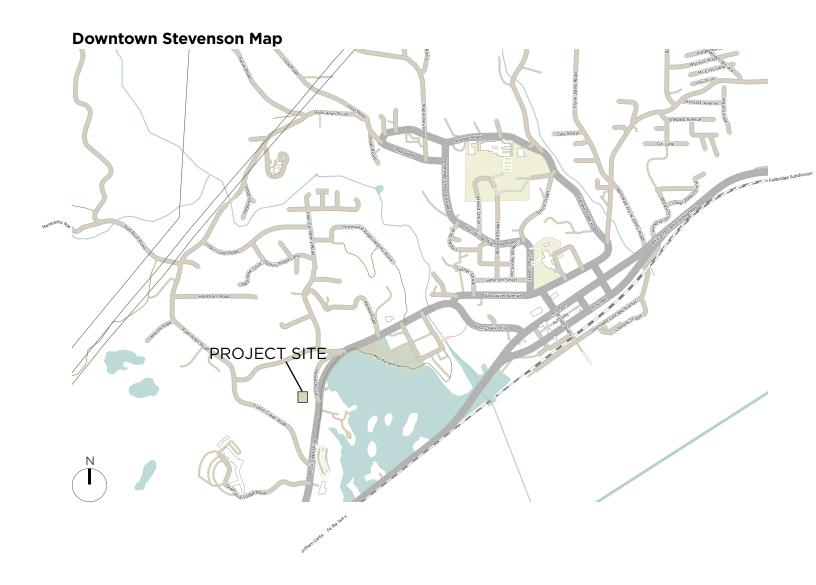
The new fire facility will be located on the corner of SW Rock Creek Road and Foster Creek Road. It is located across the street from the Columbia Gorge Interpretive Center. Mackenzie spent time on and around the site observing and photographing the surrounding buildings and context in order to better understand how best to design a new fire station well-suited Stevenson, Washington.

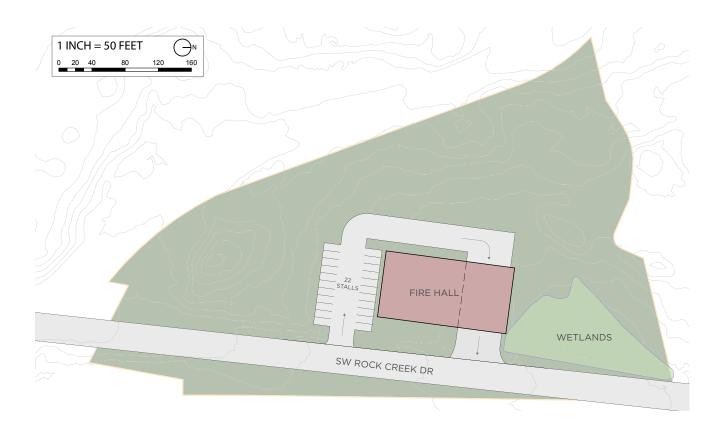
SITE OPTION A

- Very close to the wetlands.
- Majority of the building facade faces West or East, which presents challenges with controlling glare and heat gain.

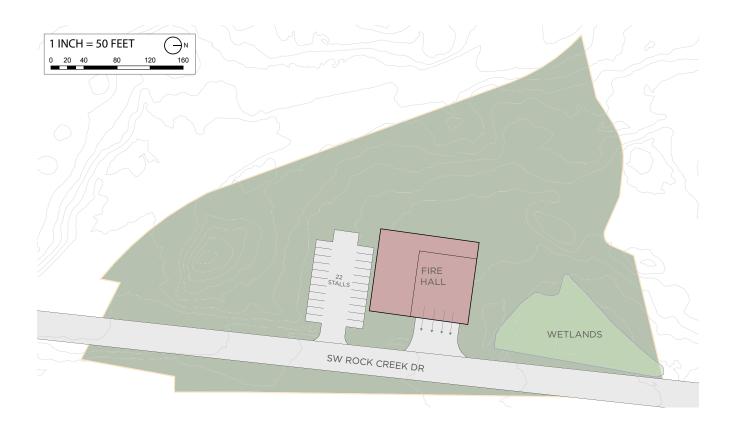
SITE OPTION B

- 70% of the building facade faces west or east, which presents challenges with controlling glare and heat gain.
- Challenging massing configuration due to square nature of the building
- Back in bays.

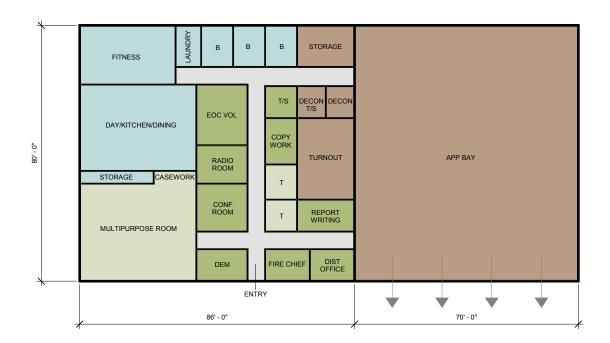
BUILDING OPTION A

Apparatus Bay and Support	6,318 SF
Living Quarters	2,019 SF
Administration and Building Support	1,494 SF
Community	1,322 SF
Total (Includes 20% circulation)	11,153 SF

A modified Option A was selected by the Department as the preferred adjacency and site plan.

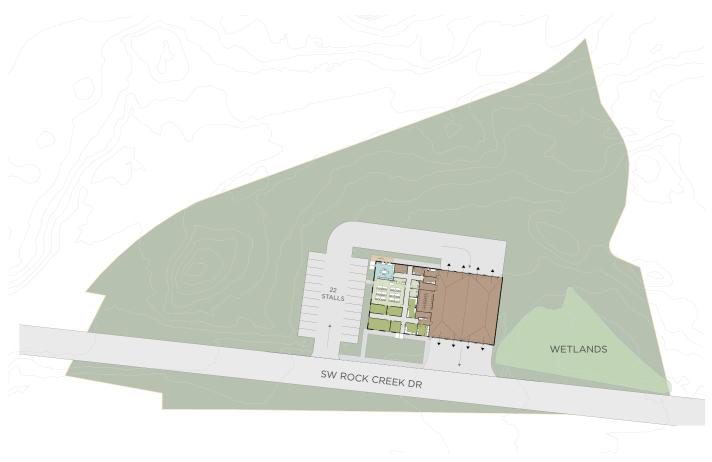
SELECTED PLAN

Site Summary

Total Site Area: 69,900 SF

Shared Parking: 30 Stalls

The approved site plan and floor plans were developed based on feedback received during review of the preliminary site plan options and block diagram schemes. During this discussion, additional site elements were identified and the plans were further refined to meet Department expectations, honing in on programmed square footages, increasing efficiencies, and taking into consideration future growth.

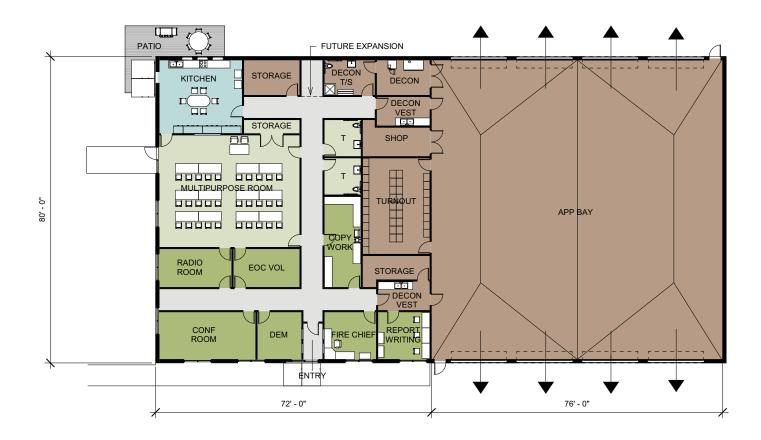
The block diagram for Option A was further refined to a floor plan level of detail in coordination with the Fire Hall Design Team. Access points into rooms, furniture, and equipment were added to further evaluate the proposed scheme and verify the design met the teams requirements.

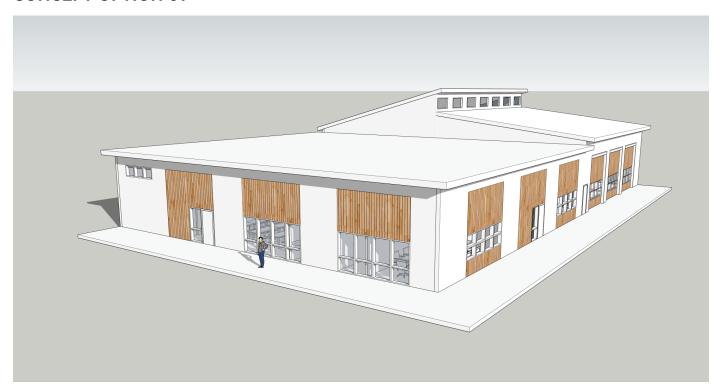
CONCEPT OPTION 01

Responding to the rhythmic repetition of openings found at the overhead doors, Option 01 uses panel-like window openings in the panels and bays of the building, which captures the qualities found in pre-engineered metal buildings. To then break up the scale and provide larger daylighting and view opportunities at appropriate interior program spaces, wood panel and larger glass openings were introduced. The two different types of roof, one gabled and the other low slope.

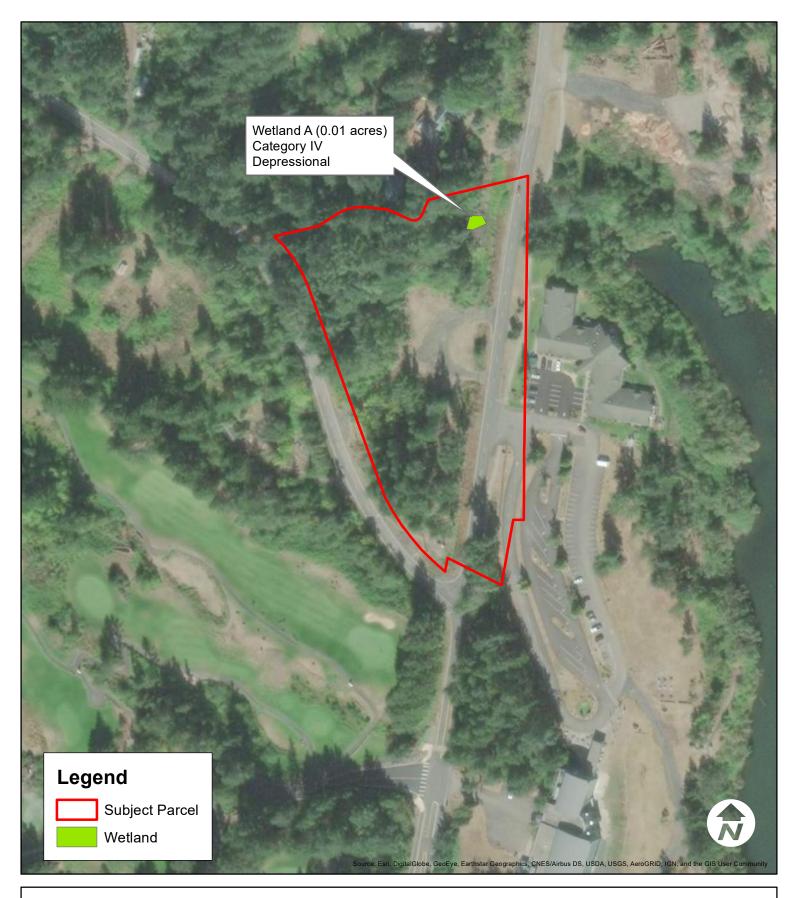
Figure 5 -Wetlands

The City's critical areas and geologic hazards map indicate the presence of a small, palustrine emergent (PEM) wetland located in the northeastern site area. Neither the National Wetland Inventory (NWI) online mapper nor Skamania County MapSifter indicates the presence of wetlands within or close to the study area. On 15 November 2018, two BergerABAM wetland scientists visited the site, conducted a wetland field investigation, and documented their findings in a wetland delineation and assessment (Appendix B). The scientists identified one wetland (Wetland A) on the northeastern part of the project site. They classified the wetland as a Category IV (lowest quality), palustrine scrub-shrub (PSS) wetland of 0.01 acre (587 square feet) with a habitat rating of 3 points.

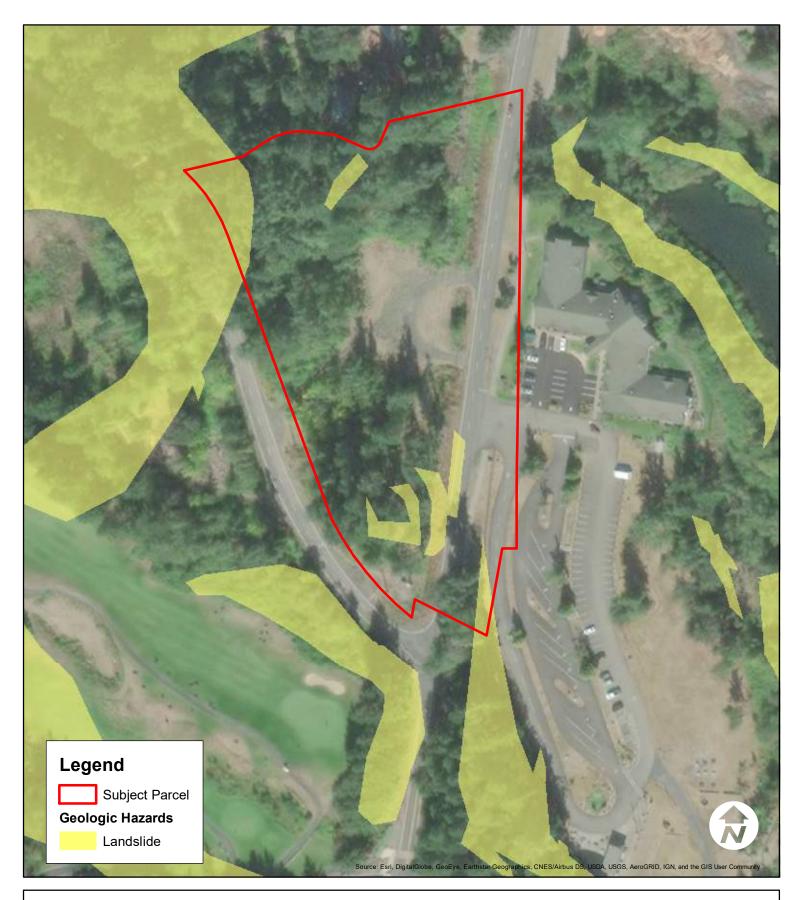
Figure 6- Geologically Hazardous Areas

The City's critical areas and geologic hazards map shows potential landslide hazards and slopes 25 percent or steeper near the western and southern property boundaries on

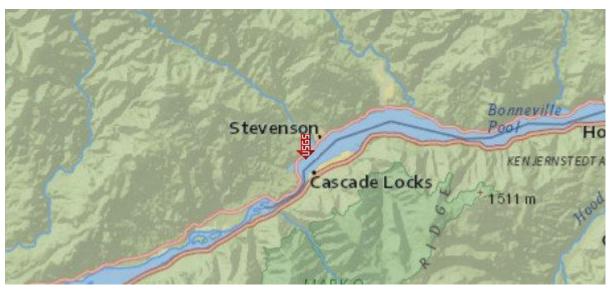
Site Soil Classification Site Class D - "Stiff Soil"

Risk Category IV (e.g. essential facilities)

USGS-Provided Output

$$S_s = 0.657 g$$
