# ROCK COVE ENVIRONMENTAL EVALUATION AND COMPREHENSIVE PLAN

**Skamania County  
Department of Planning and Community Development**

**Fishman Environmental Services  
with  
CDA Group  
GreenWorks PC  
Watershed Applications  
Water Resource Management**

**October 30, 1997**

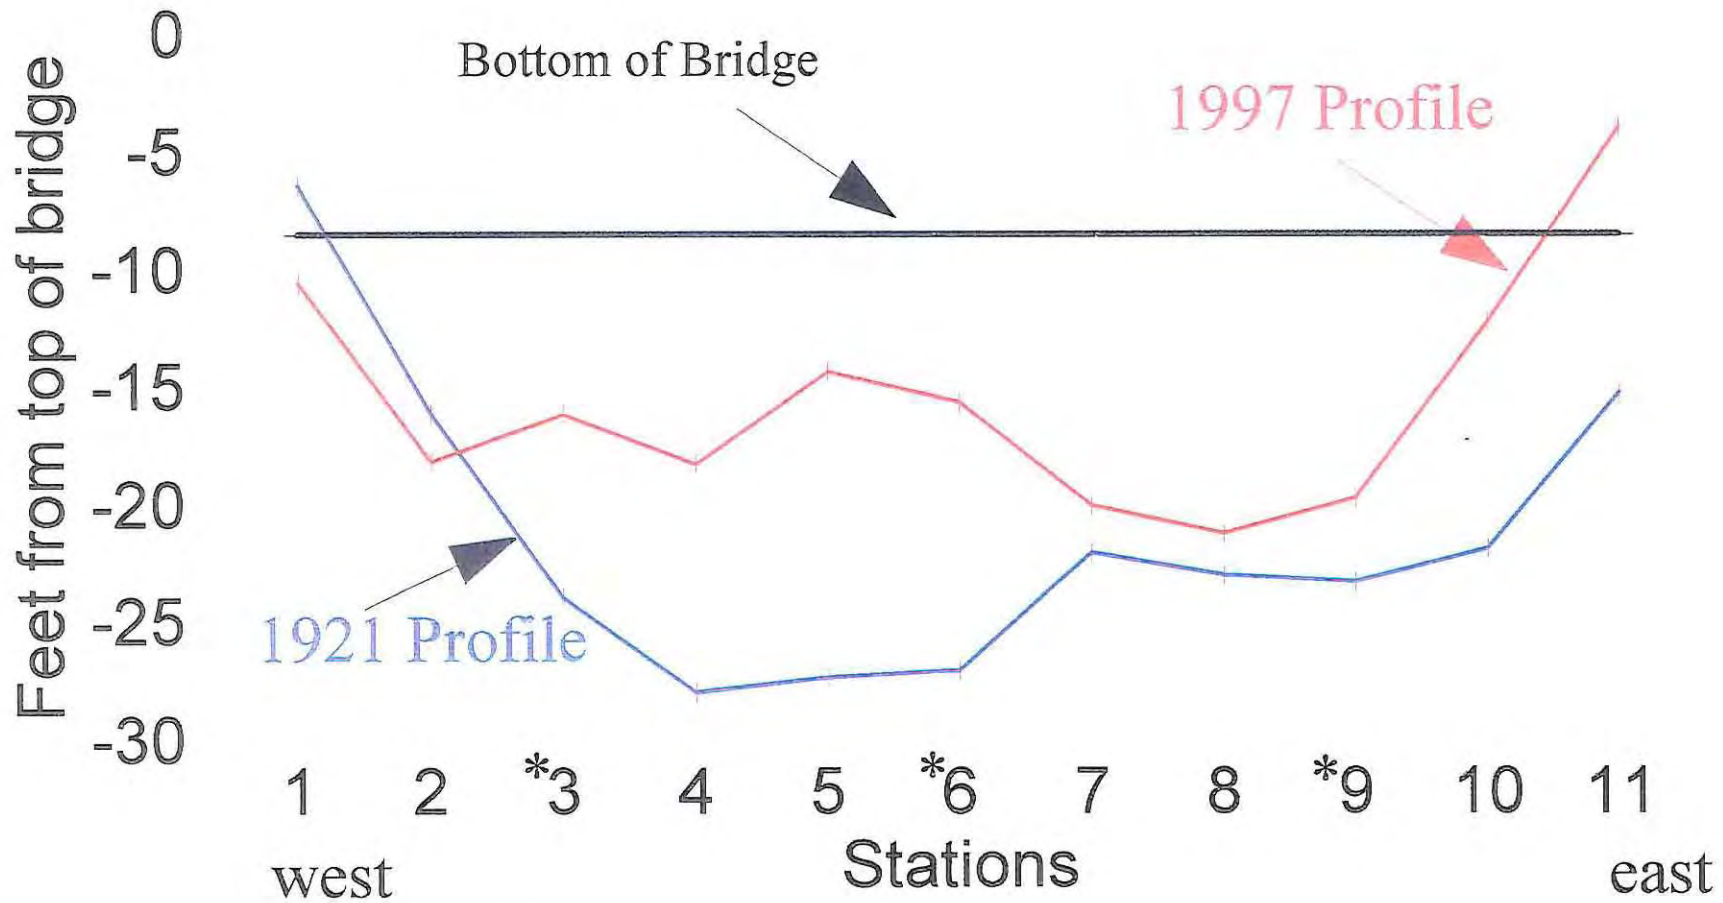
# Rock Creek Channel Cross Section

At Concrete Bridge

\* Bridge support locations

The channel profile figure of Rock Creek was created to get an idea of the degree of accretion of material in Rock Creek. Specifically, this graph shows the formation of the bar in the center of Rock Creek. It would be useful to look at the channel profile for several points in time between 1921 and 1997 rather than just the two points in time. A time series would provide some understanding of how the accretion of the bar has occurred, and several small events or as a gradual process over the years. If data are unavailable for a time series through the years, at least these data could be expanded upon in the future to try to better understand the processes acting on Rock Creek. Additionally, this figure could be used as a justification for getting funding to either remove the material from the bar or replace the bridge to a type that will not be threatened by flood events.

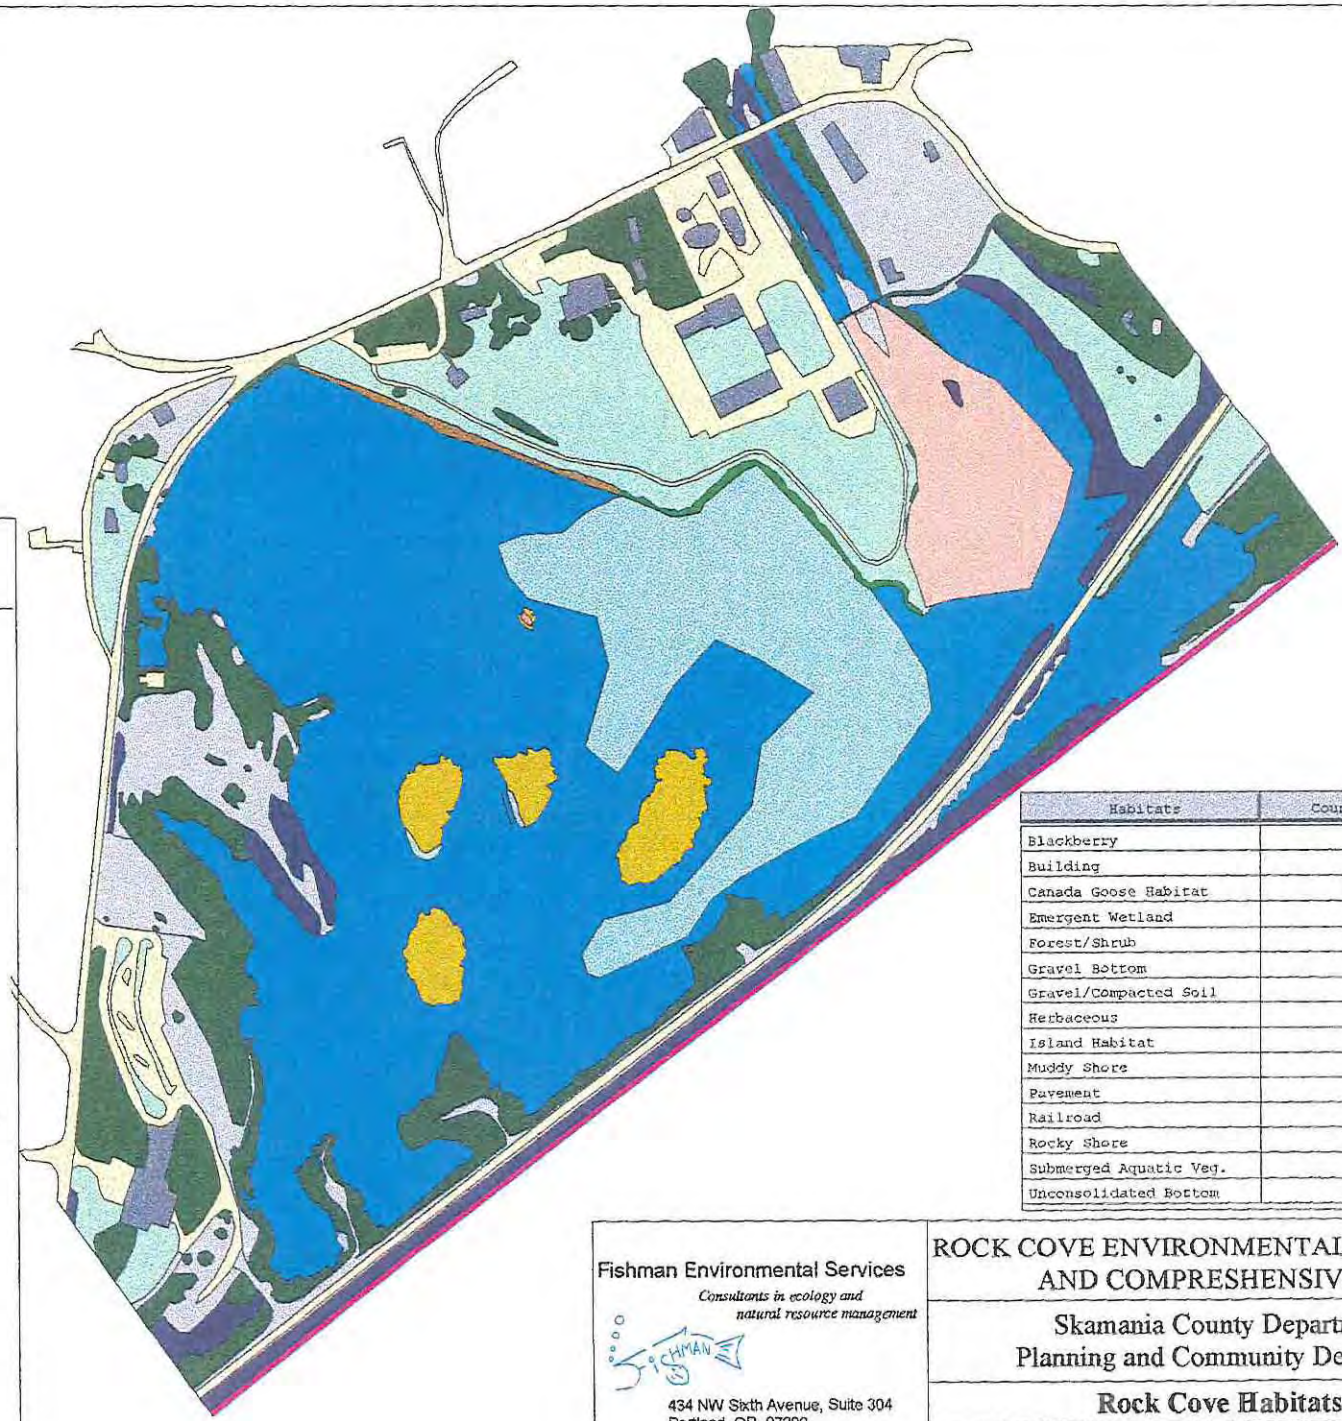
**Figure B-1**

## Rock Cove Habitats

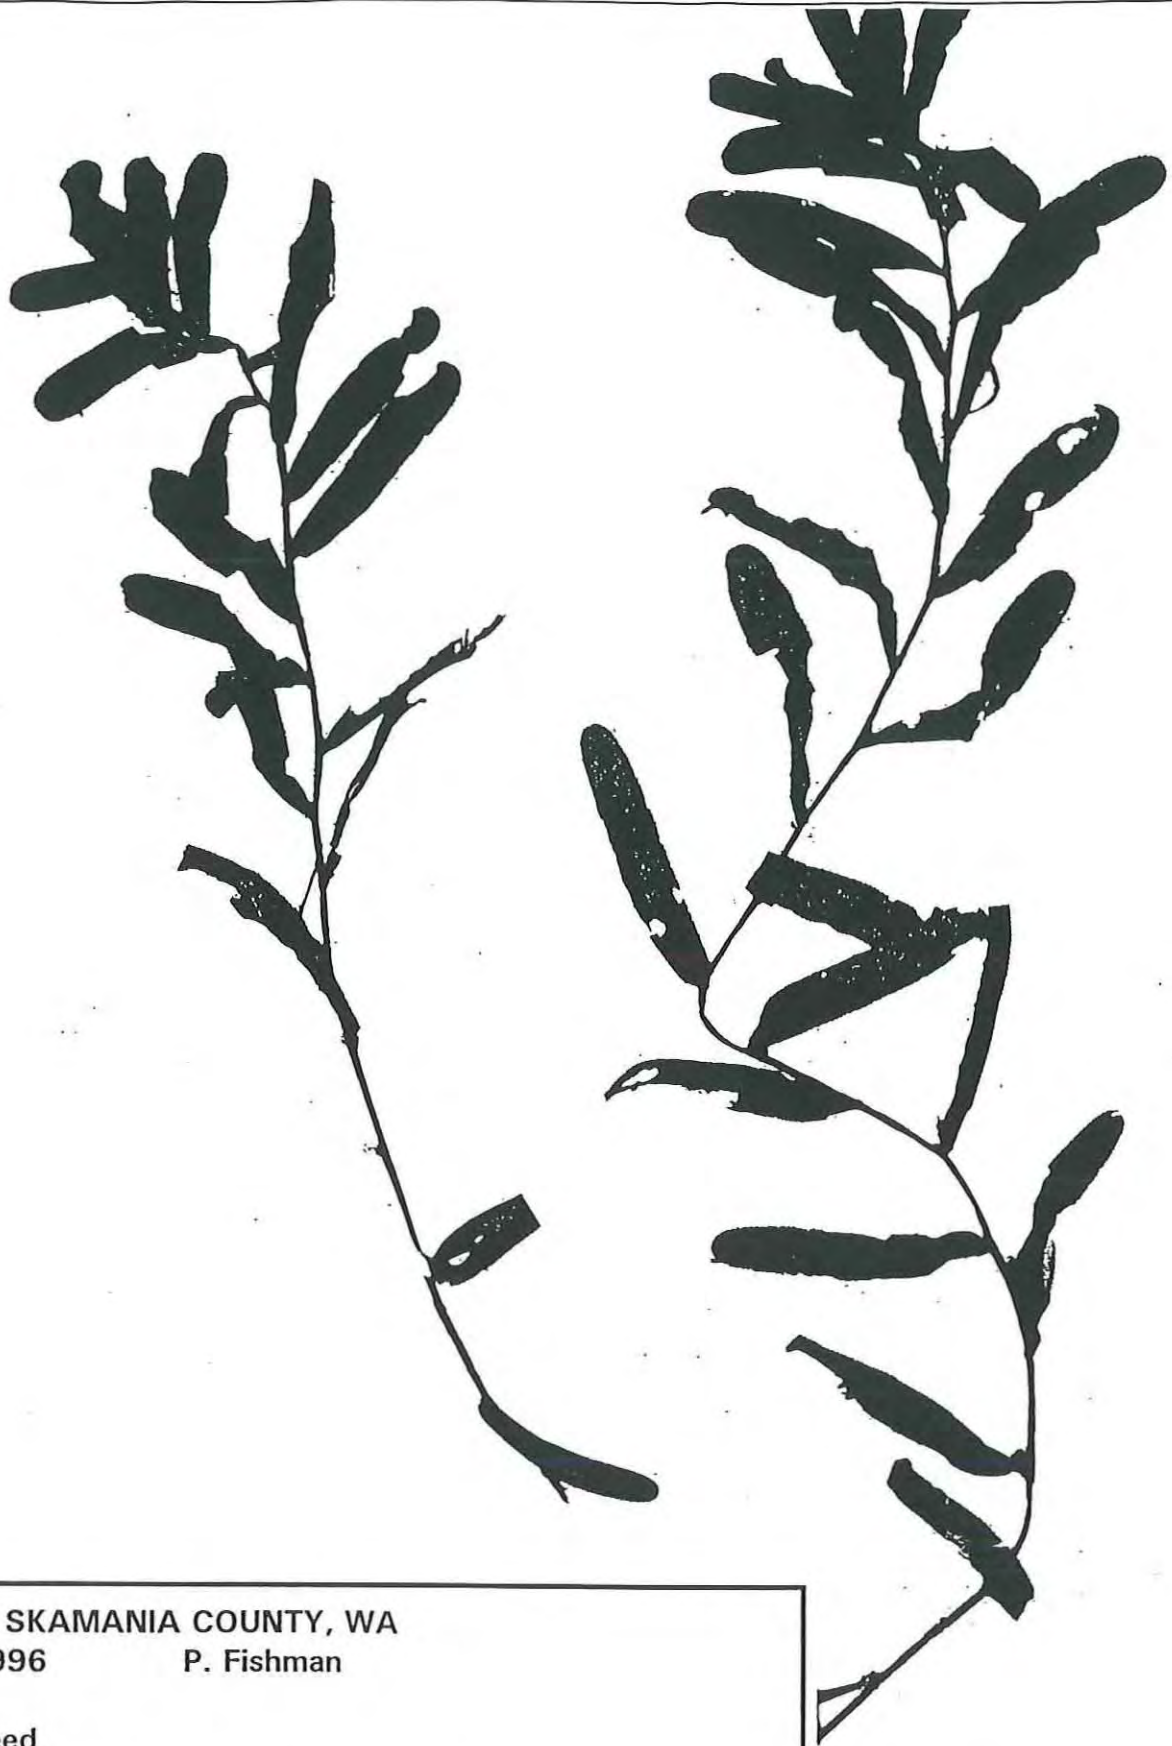
Figure B-4

Curly pondweed  
*Potamogeton crispus*

- non-native plant mostly found from late June through August in lakes and streams; sometimes becomes a pest
- provides habitat for small fish and invertebrates

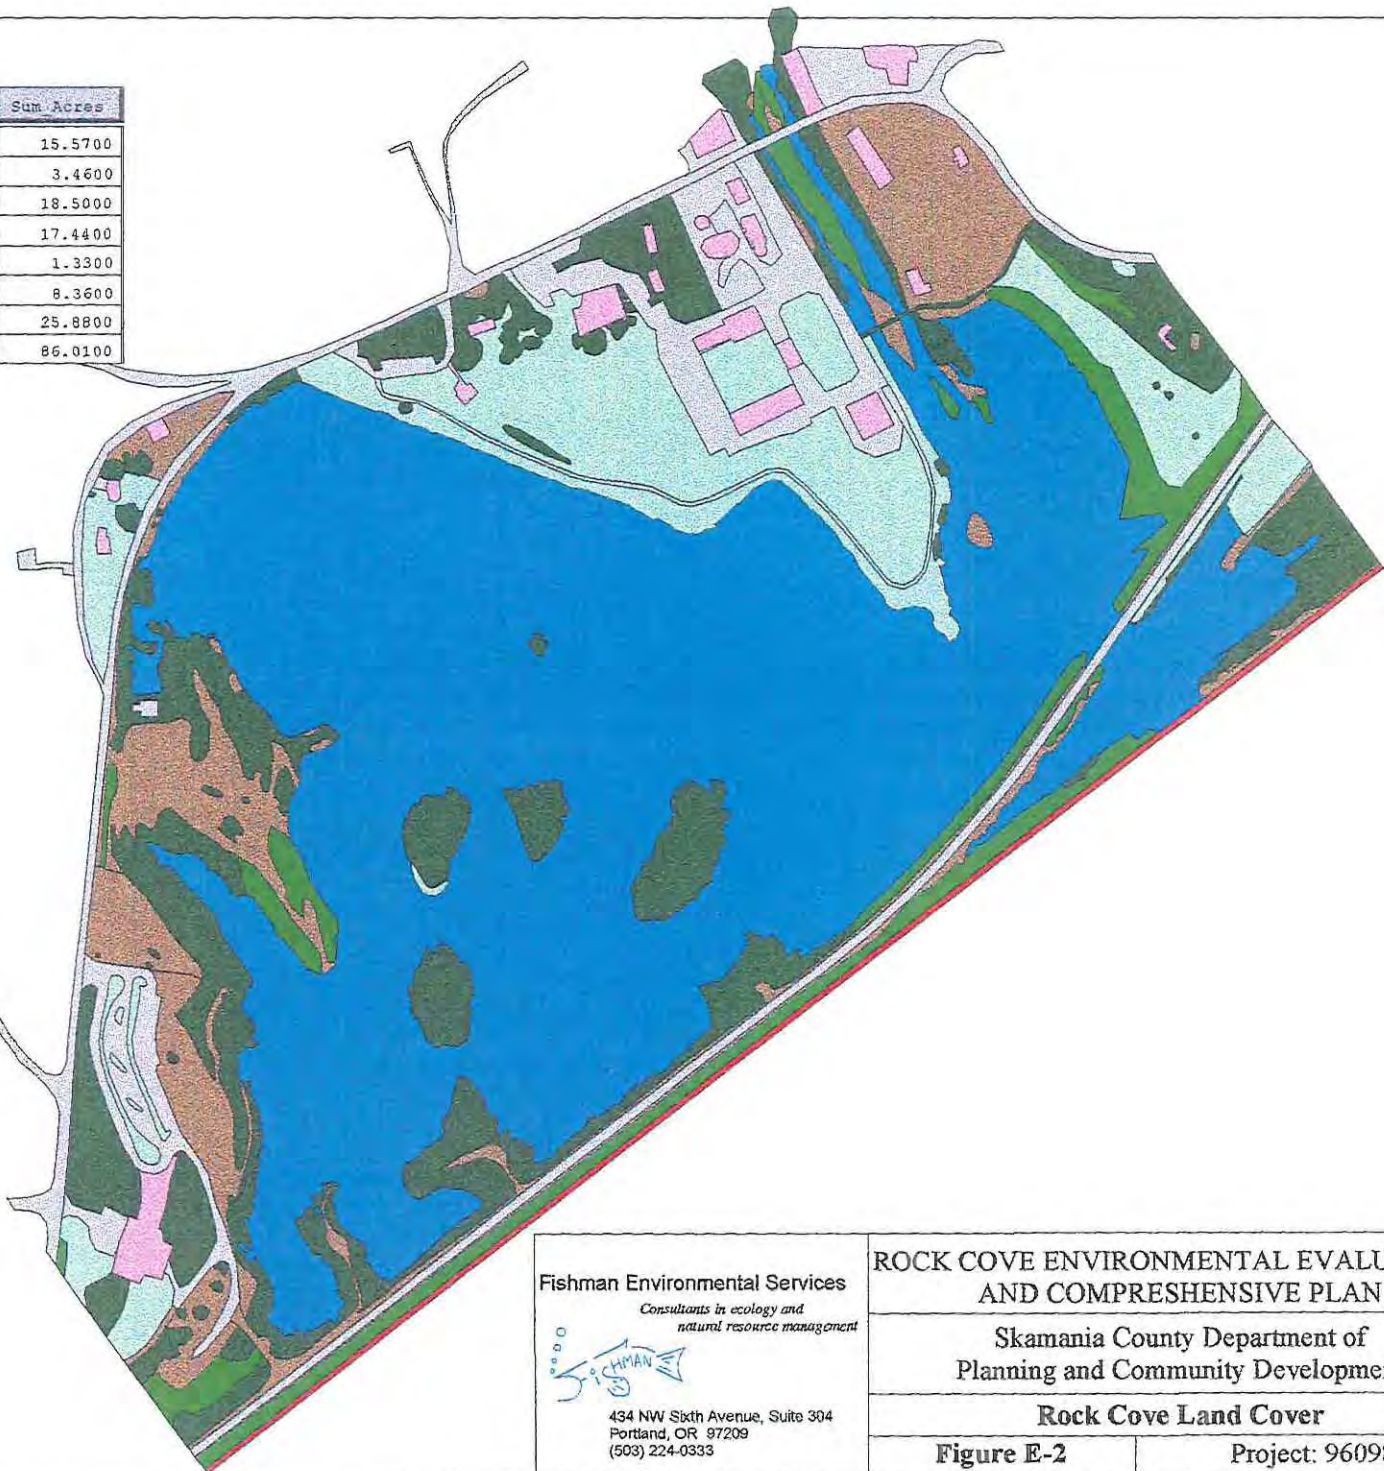
- Land Cover
- Bare
  - Building
  - Grass
  - Pavement
  - Railroad
  - Shrub
  - Trees
  - Water

In order to get a better understanding of the potential impacts to Rock Cove a land cover map was created (see Figure F-2). This map shows each land cover type as a different color. Since this map was created using GIS a table is associated with the map. The table here shows the acreage for each land cover type. Getting an understanding of the types of land cover and the percentage of each land cover is one starting point for understanding the degree of development and whether an area shows signs of environmental impact. For instance the degree to which an area is covered with impervious surfaces is indirectly proportional to the amount of plants which can grow in that same area. The impervious surfaces in the project area account for twelve percent of the total study area or twenty three percent of the non-water areas.

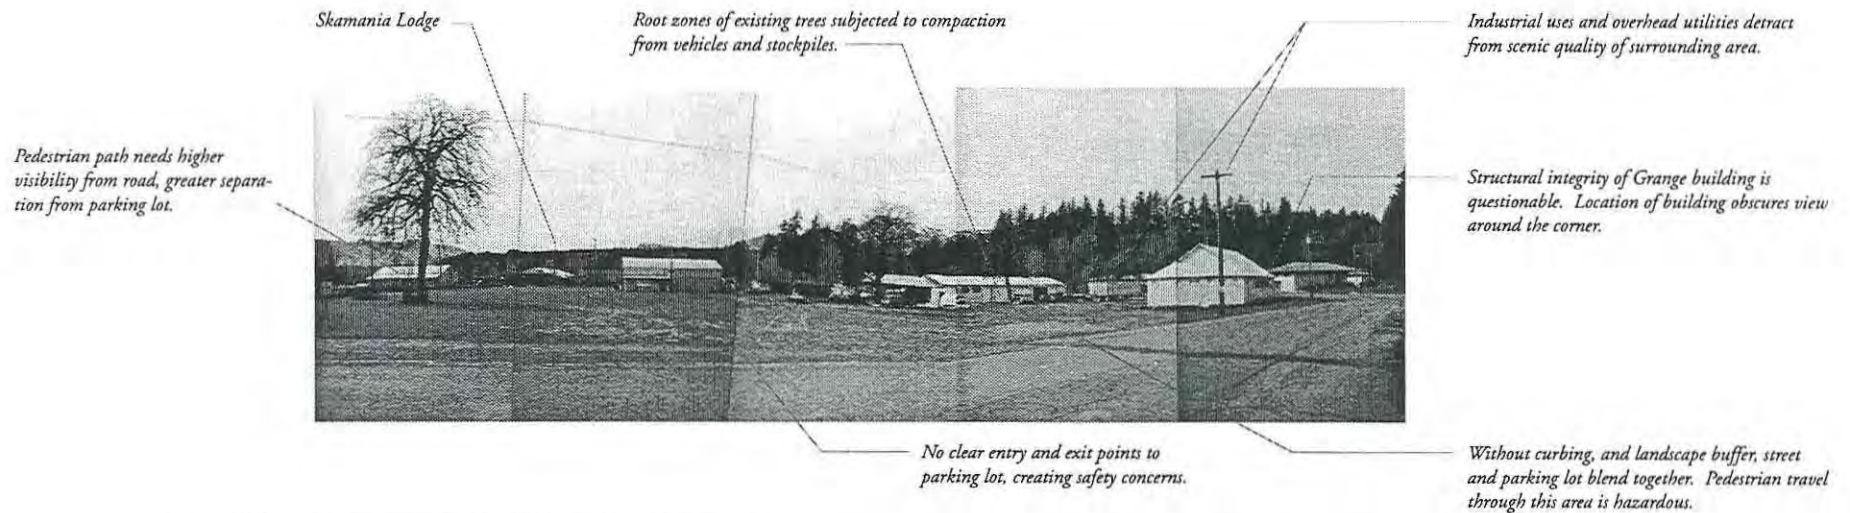
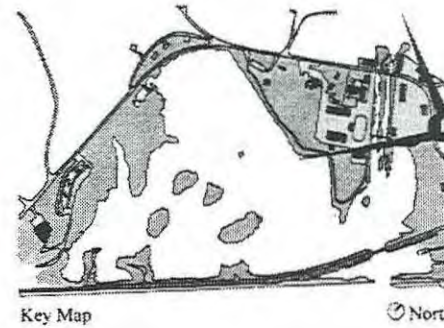
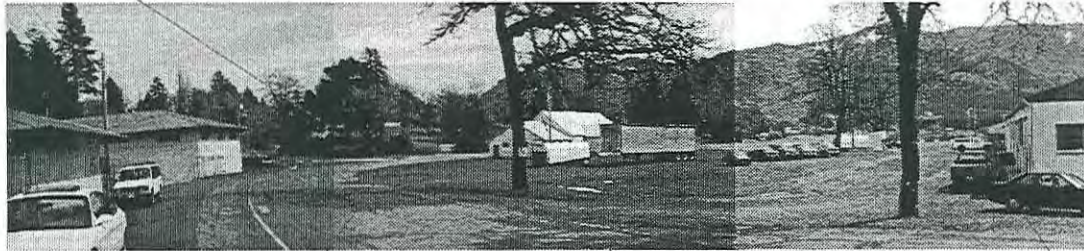
## Viewpoint #1

LOCATION: Westbound on Rock Creek Drive at Motor Pool Building.

VIEWPOINT SIGNIFICANCE: This site is the westbound gateway to the fairgrounds, Rock Creek and the Cove.

NOTES: The industrial character of the foreground dominates the space, contrasting sharply with its creekside setting, overwhelming distant view of the mountains and Skamania Lodge and giving no clue to the adjacent recreational opportunities. Broad expanses of pavement provide minimal definition of the various circulation routes through the space.

*Residential area looks directly into industrial area.*

*Structural integrity of Grange building is questionable.*

*Root zones of existing trees subjected to compaction from vehicles and stockpiles.*

*No clear entry and exit points into parking lot.*

*Poor drainage contributes to puddling.*

- RECOMMENDATIONS:
1. Relocate the Grange building.
  2. Create a landscape buffer between the road and the parking lot to screen industrial uses and to clearly define the road.
  3. Enhance pathway to existing pedestrian bridge and create a clear separation between the path and the parking lot. Use landscape materials and signs to clarify pathway to the fairgrounds.
  4. Protect existing trees with curbed planting beds within the driplines.
  5. Create clear entry and exit points to the parking lot to improve safety.
  6. Bury overhead utility lines.

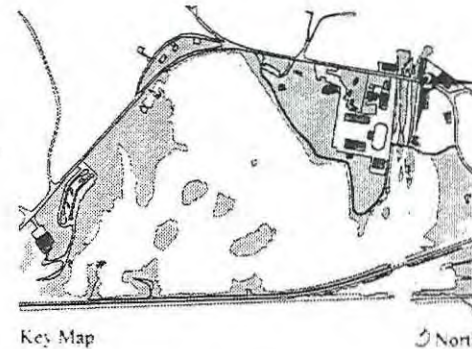
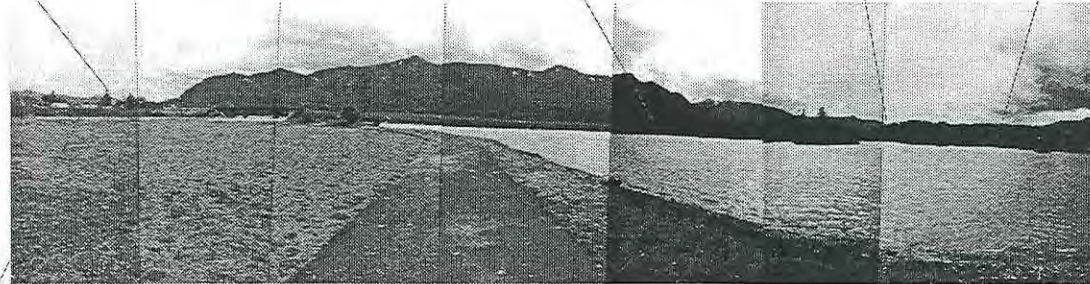
## Viewpoint #2

NOTES: The industrial character of the site contrasts sharply with what is expected after emerging from basalt bluff and park to the west and detracts from views of the Gorge to the south. Broad expanses of pavement provide minimal definition of the various circulation routes through the space. There is no screening of the industrial area from the adjacent residential zone.

*Western gateway to Stevenson.*

*Lack of vegetation contributes to erosion at shoreline.*

*Poor spacial definition of this focal area for the fair and concerts.*

*Minimal separation of path from adjacent field.*

- RECOMMENDATIONS:
1. Maximize efficiency and appearance of the parking lot with striping, landscape islands and improved drainage.
  2. Create separation between the buildings and the parking lot with landscaping.
  3. Relocate Grange building.
  4. Create a landscape buffer between the road and the parking lot to screen industrial uses and to clearly define the road. Provide a 5' wide sidewalk in conjunction with landscape buffer.
  5. Protect existing trees with curbed planting beds within the driplines.
  6. Create clear entry and exit points into the parking lot to improve safety.

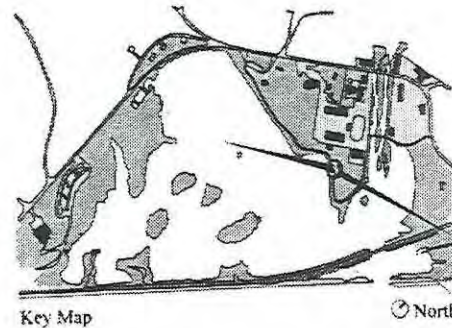
## Viewpoint #3

**LOCATION:** On pedestrian path along western edge of peninsula looking south.

**NOTES:** This is a very open site with unobstructed views in every direction but with most attention focused on the south wall of the Gorge. The view to the west reveals the more natural side of the cove with Skamania Lodge and the Columbia Gorge Interpretive Center visible in the distance, while the view to the east provides a brief glimpse of boat traffic on the Columbia River and an introductory view of Stevenson.

*Continued use of lawn by large numbers of geese contributes to erosion, health and aesthetic concerns.*

- RECOMMENDATIONS:**
1. Stabilize shoreline with riparian vegetation.
  2. Plant vegetation in pockets within riprap at highway shoreline to create a more natural appearance.
  3. Use low berms and vegetation along inside edge of path to help define the edges and to focus views from pathway outward.
  4. Plant trees along path to provide foreground interest and to enhance views from highway into the fairgrounds.
  5. Consider the visual impact of future development at gateway to Stevenson.

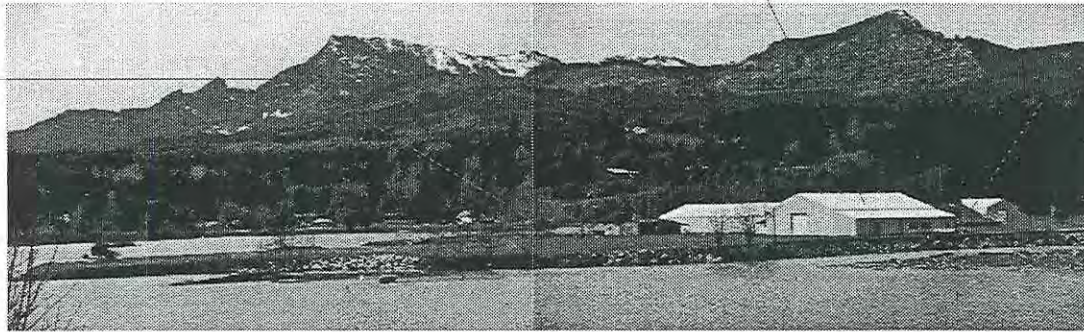
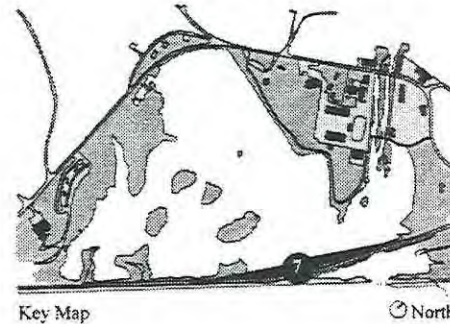
## Viewpoint #7

*White roofs and light green color of the Fairground buildings contrast with dark vegetation in the background.*

*Campers highly visible in this area during fairs and festivals.*

*Shoreline shows evidence of substantial erosion.*

**LOCATION:** On east bank of Rock Creek looking toward Cove.

1. Use riparian vegetation to create irregular edges for the shoreline and to reduce erosion potential.
2. Screen fairground buildings and large lawn areas with vegetation and low berms to improve visual compatibility with surrounding area.
