# **City Of Stevenson Street Tree Inventory and Management Plan**

The City of Stevenson, Washington
March 2, 2022

**Urban Forestry Services | Bartlett Consulting**

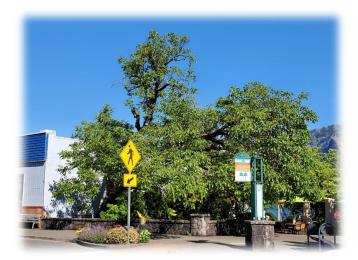
Photo 10, 11. Tree #166, shown in both photos, is a historic walnut that shades a community area. This tree is in poor condition with a lean and a buried root flair. Further assessment is recommended of the roots and trunk if this tree is to be retained.

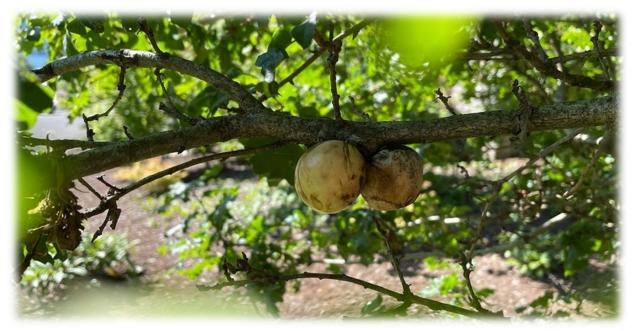
Photo 26. An oak apple gall on a Garry oak. While odd and sometimes startling, these galls are typically harmless and do not typically require management intervention

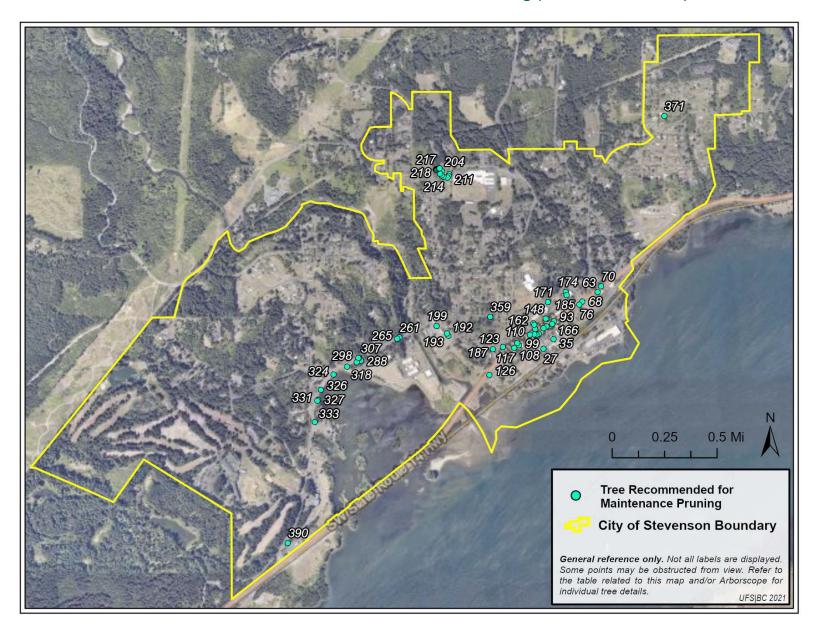
# Street Trees Recommended for Maintenance Pruning (Phase ASAP, 1 & 2)

Tree ID	Common Name	DBH	Pruning Goal	Defect(s) or Observation(s)	Work Phase
35	Maple-Norway	12	Reduce risk of branch stem and/or root failure	Broken branch(s) Dieback (severe)	ASAP
70	Ash-Green	6	Reduce risk of branch stem and/or root failure Reduce weight of branch ends Clearance	Broken branch(s) Storm damage Wound-branch	ASAP
166	Walnut-Persian	26	Clearance Reduce risk of branch stem and/or root failure Reduce weight of branch ends	Cavity-branch Dieback (severe) Overextended branch Topping/heading cuts	ASAP
204	Elm-American	11	Develop branch structure Improve form and shape	Storm damage Uneven crown	ASAP
103	Linden-Littleleaf	13	Reduce weight of branch ends Reduce density Clearance	Corrected lean Included bark	1
108	Linden-Littleleaf	13	Reduce weight of branch ends Reduce density	Corrected lean Decay-stem Flush cuts Girdling material	1
114	Maple-Norway	24	Reduce weight of branch ends Reduce risk of branch stem and/or root failure	Crack-stem Decay-branch Girdling material Uneven crown	1

117	Linden-Littleleaf	10	Clearance Reduce weight of branch ends	Flush cuts Girdling material Included bark Storm damage	1
162	Sweetgum- Common	22	Reduce risk of branch stem and/or root failure Develop branch structure	Girdling roots present Storm damage	1
171	Tuliptree	48	Reduce risk of branch stem and/or root failure Reduce weight of branch ends	Broken branch(s) Overextended branch Topping/heading cuts	1
174	Oak-Oregon White	45	Reduce risk of branch stem and/or root failure	Dead branches >2 Overextended branch Storm damage	1
217	Douglas Fir	19,30	Reduce risk of branch stem and/or root failure Clearance	Co-dominant stems Overextended branch	1
218	Douglas Fir	21,8	Reduce risk of branch stem and/or root failure	Overextended branch	1

Tree ID	Common Name	DBH	Pruning Goal	Defect(s) or Observation(s)	Work Phase
			Reduce weight of branch ends		
219	Douglas Fir	13	Reduce risk of branch stem and/or root failure	Overextended branch	1
220	Douglas Fir	24	Reduce risk of branch stem and/or root failure	Overextended branch	1
222	Douglas Fir	21,23	Reduce risk of branch stem and/or root failure	Co-dominant stems Overextended branch	1
223	Douglas Fir	27	Reduce risk of branch stem and/or root failure Reduce likelihood of storm damage Reduce weight of branch ends	Overextended branch	1
224	Douglas Fir	17	Reduce risk of branch stem and/or root failure		1
288	Oak-Oregon White	13	Reduce risk of branch stem and/or root failure Develop branch structure Reduce weight of branch ends	Overextended branch Uneven crown	1
298	Oak-Oregon White	10	Clearance Develop branch structure	Broken branch(s) Wound-branch	1
318	Maple-Bigleaf	19,25	Reduce risk of branch stem and/or root failure Develop branch structure	Co-dominant stems Dieback (moderate) Overextended branch	1

327	Oak-Oregon White	45	Reduce risk of branch stem and/or root failure Improve appearance	Broken branch(s) Dead branches >2	1
331	Oak-Oregon White	22	Reduce risk of branch stem and/or root failure Reduce weight of branch ends	Overextended branch Uneven crown	1
333	Maple-Norway	16	Repair storm damage Clearance Develop branch structure	Broken branch(s) Storm damage Topping/heading cuts	1
359	Elm-American	71	Reduce size of crown Reduce risk of branch stem and/or root failure	Co-dominant stems Dead branches <=2 Overextended branch	1
27	Maple-Norway	10,2	Reduce size of crown	Cavity-stem Co-dominant stems Uneven crown	2
63	Ash-Green	7	Repair storm damage Improve appearance Improve form and shape	Broken branch(s) Poor branch structure Storm damage	2
68	Linden-Littleleaf	11	Develop branch structure Reduce size of crown Reduce weight of branch ends	Co-dominant stems Corrected lean	2
76	Maple-Norway	18	Reduce risk of branch stem and/or root failure Reduce weight of branch ends Clearance	Co-dominant stems Wound-branch	2

93	Maple- Freeman's	8	Clearance Repair storm damage	Co-dominant stems Crack-stem Included bark Storm damage Wound-branch	2
95	Maple-Norway	12	Clearance	Dead branches <=2	2

Tree ID	Common Name	DBH	Pruning Goal	Defect(s) or Observation(s)	Work Phase
			Reduce size of crown Reduce weight of branch ends	Girdling material Topping/heading cuts	
96	Maple-Red	11	Reduce size of crown Clearance Reduce risk of branch stem and/or root failure	Co-dominant stems Decay-root flare Flush cuts Girdling material	2
99	Linden-Littleleaf	12	Clearance Reduce weight of branch ends Develop branch structure	Co-dominant stems Flush cuts Girdling material Included bark	2
104	Linden-Littleleaf	14	Reduce weight of branch ends Reduce density Clearance	Flush cuts Girdling material Overextended branch Poor branch structure	2
105	Linden-Littleleaf	14	Clearance Reduce weight of branch ends Reduce size of crown	Girdling material	2
110	Linden-Littleleaf	12	Reduce weight of branch ends Reduce density Clearance	Dieback (moderate) Flush cuts Girdling material Included bark	2
123	Poplar-Aspen	12	Clearance Reduce weight of branch ends	Co-dominant stems Included bark	2

126	Maple-Vine	3,4,4,1	Reduce density Clearance	Dead branches <=2	2
147	Linden-Littleleaf	10	Reduce density Develop branch structure Reduce weight of branch ends	Corrected lean Girdling material Included bark Storm damage	2
148	Linden-Littleleaf	12	Develop branch structure Reduce density Reduce weight of branch ends	Co-dominant stems Storm damage	2
163	Sweetgum- Common	26	Develop branch structure Repair storm damage Improve light and air penetration through crown	Overextended branch Storm damage Topping/heading cuts	2
185	Pine-Lodgepole	23	Clearance Reduce risk of branch stem and/or root failure	Broken branch(s) Dead branches >2	2
187	Maple- Freeman's	7	Clearance Reduce risk of branch stem and/or root failure Repair storm damage	Decay-branch Decay-stem Topping/heading cuts	2
192	Maple-Norway	5	Clearance Promote development of strong central stem	Co-dominant stems Crack-stem Decay-stem	2
193	Maple-Norway	7	Clearance Reduce size of crown	Crack-stem Lean Sunscald (severe)	2

199	Maple-Norway	4	Improve appearance	Crack-stem Dead branches >2 Dieback (severe)	2
210	Elm-American	14	Develop branch structure Improve form and shape	Broken branch(s) Topping/heading cuts	2

Tree ID	Common Name	DBH	Pruning Goal	Defect(s) or Observation(s)	Work Phase
				Wound-root flare	
211	Elm-American	17	Develop branch structure Improve form and shape	Co-dominant stems Included bark Topping/heading cuts	2
212	Elm-American	26	Develop branch structure Improve form and shape	Broken branch(s) Dieback (severe) Topping/heading cuts	2
214	Elm-American	22	Develop branch structure Improve form and shape	Co-dominant stems Topping/heading cuts	2
215	Elm-American	24	Develop branch structure Improve form and shape	Co-dominant stems Included bark Topping/heading cuts	2
216	Elm-American	27	Develop branch structure Improve form and shape	Broken branch(s) Co-dominant stems Included bark Topping/heading cuts	2
261	Douglas Fir	13	Clearance	Broken branch(s)	2
265	Douglas Fir (8)	7,6,10,6,7,12	Clearance	Broken branch(s)	2
306	Oak-Oregon White	24	Reduce risk of branch stem and/or root failure Reduce weight of branch ends	Broken branch(s) Hanger Storm damage Wound-branch	2

307	Oak-Oregon White	24	Clearance Reduce weight of branch ends	Overextended branch	2
324	Douglas Fir	30	Clearance Improve appearance	Broken branch(s) Sidewalk lifting-minor	2
326	Douglas Fir	6	Clearance Improve appearance	Broken branch(s)	2
371	Western Redcedar	42	Clearance	Girdling roots present (moderate)	2
390	Alder-Red (10)	10	Reduce risk of branch stem and/or root failure		2

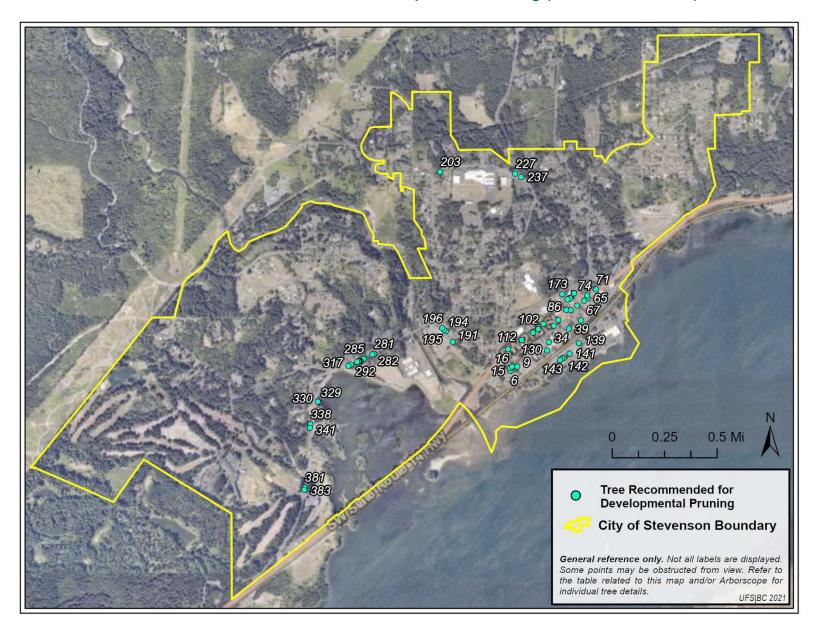
# Street Trees Recommended for Developmental Pruning (Phase ASAP, 1 & 2)

Tree ID	Common Name	DBH	Pruning Goal	Defect(s) or Observation(s)	Work Phase
71	Ash-Green	5	Clearance	Broken branch(s) Construction damage Flush cuts Storm damage	ASAP
74	Ash-Green	11	Reduce weight of branch ends Promote development of strong central stem	Co-dominant stems Included bark Overextended branch	ASAP
112	Maple-Norway	21	Reduce weight of branch ends	Co-dominant stems Included bark Overextended branch Storm damage	ASAP
173	Maple-Vine	3,3,4,3,3,4	Clearance	Broken branch(s) Dead branches >2	ASAP
203	Elm-American	11	Develop branch structure	Broken branch(s) Storm damage Topping/heading cuts	ASAP
6	Maple- Freeman's	4	Promote development of strong central stem Clearance	Co-dominant stems Sunscald (moderate)	1
65	Maple- Freeman's	3	Promote development of strong central stem	Co-dominant stems Girdling material	1
102	Linden-Littleleaf	14	Reduce density Reduce weight of branch ends Clearance	Flush cuts Girdling material Included bark	1

109	Maple- Freeman's	7	Promote development of strong central stem Clearance	Co-dominant stems Included bark	1
177	Mountain Ash- American	4	Promote development of strong central stem	Broken branch(s) Storm damage	1
178	Maple-Norway	11	Repair storm damage Develop branch structure Promote development of strong central stem	Broken branch(s) Storm damage Wound-branch	1
180	Douglas Fir	17	Clearance	Broken branch(s) Corrected lean Uneven crown	1
183	Maple-Bigleaf	11,7	Promote development of strong central stem Clearance	Broken branch(s) Buried root collar Co-dominant stems	1
282	Oak-Oregon White (4)	12,8,19,26	Develop branch structure	Co-dominant stems Included bark	1

Tree	Common	DBH	Pruning Goal Defect(s) or		Work
ID	Name			Observation(s)	Phase
289	Oak-Oregon White	13,11	Develop branch structure Reduce weight of branch ends	Broken branch(s) Co-dominant stems Overextended branch	1
290	Oak-Oregon White	15	Develop branch structure Reduce weight of branch ends	Co-dominant stems Included bark Overextended branch	1
291	Oak-Oregon White	12	Develop branch structure	Broken branch(s)	1
292	Oak-Oregon White	11	Develop branch structure	Broken branch(s)	1
293	Oak-Oregon White	16	Develop branch structure Reduce weight of branch ends Improve form and shape	Broken branch(s) Overextended branch Topping/heading cuts	1
294	Oak-Oregon White	16,12	Develop branch structure Reduce weight of branch ends Improve form and shape	Co-dominant stems Dead branches >2 Overextended branch Topping/heading cuts	1
296	Oak-Oregon White	18	Reduce weight of branch ends Develop branch structure	Broken branch(s) Buried root collar Overextended branch	1

317	Ash-Oregon	4,3	Promote development of strong central stem	Broken branch(s) Co-dominant stems	1
9	Maple-Norway	3	Promote development of strong central stem Clearance	Co-dominant stems	2
15	Maple- Freeman's	9	Clearance Promote development of strong central stem Develop branch structure		2
16	Maple-Norway	11	Develop branch structure Clearance	Included bark	2
34	Maple- Freeman's	2	Promote development of strong central stem		2
39	Maple-Hedge	9	Clearance Develop branch structure		2
43	Maple- Freeman's	2	Promote development of strong central stem		2
67	Maple- Freeman's	2	Develop branch structure		2
77	Maple-Norway	3	Clearance	5	2
80	Maple- Freeman's	2	Clearance	Broken branch(s)	2
86	Maple- Freeman's	2	Clearance Promote development of strong central stem	Sidewalk lifting-minor	2
91	Maple-Red	7	Clearance Develop branch structure	Flush cuts	2
116	Linden-Littleleaf	8	Promote development of strong central stem Develop branch structure Reduce density	Co-dominant stems Storm damage	2

Tree	Common	DBH	Pruning Goal	Defect(s) or	Work
ID	Name			Observation(s)	Phase
139	Maple- Freeman's	4	Promote development of strong central stem	Co-dominant stems	2
141	Maple- Freeman's	6	Promote development of strong central stem	Co-dominant stems	2
142	Maple- Freeman's	3	Promote development of strong central stem		2
143	Maple- Freeman's	3	Promote development of strong central stem		2
144	Maple- Freeman's	3	Promote development of strong central stem	Storm damage	2
145	Linden-Littleleaf	14	Reduce density Develop branch structure	Co-dominant stems Storm damage	2
167	Pine-Lodgepole	8,9	Improve form and shape	Storm damage Topping/heading cuts	2
181	Douglas Fir	15	Clearance	Broken branch(s)	2
191	Maple-Norway	5,4,2,2	Clearance	Co-dominant stems	2
194	Maple-Norway	7	Reduce weight of branch ends Clearance	Crack-stem	2
195	Maple-Norway	11	Promote development of strong central stem Reduce risk of branch stem and/or root failure Reduce size of crown	Co-dominant stems	2

196	Maple-Norway	7	Clearance	Crack-stem	2
227	Maple- Freeman's	2	Promote development of strong central stem	Co-dominant stems	2
237	Maple- Freeman's	2	Promote development of strong central stem	Co-dominant stems	2
281	Oak-Oregon White	23	Develop branch structure	Co-dominant stems Overextended branch	2
285	Douglas Fir	40	Reduce weight of branch ends Clearance	Overextended branch	2
316	Oak-Oregon White	6	Promote development of strong central stem	Co-dominant stems	2
329	Oak-Oregon White	18	Reduce weight of branch ends	Crack-stem Uneven crown	2
330	Oak-Oregon White	25,17	Reduce weight of branch ends Reduce risk of branch stem and/or root failure	Broken branch(s) Co-dominant stems Included bark	2
338	Oak-Oregon White	9	Reduce weight of branch ends	Broken branch(s) Overextended branch	2
341	Oak-Oregon White	11	Develop branch structure Improve form and shape	Broken branch(s) Topping/heading cuts	2
381	Maple-Vine	3,3,3,2	Improve form and shape Clearance	Co-dominant stems	2

383	Maple-Vine	3,2,2,2	Clearance Improve form and shape	Co-dominant stems	2

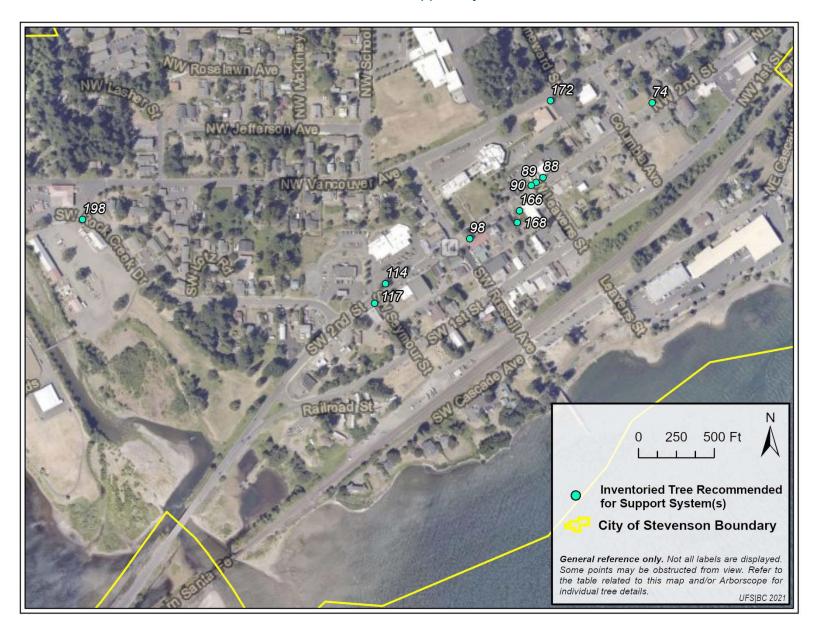
# Inventoried Trees with Structural Support System Recommendations

Photo36, 37. Tree #98 and 114 are mature and cannot be easily pruned for correction. Both canopies can be cabled to prevent future snow, ice and storm damage.

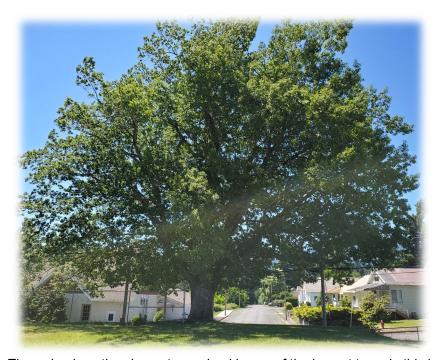
Photo 38. The red oak on the elementary school is one of the largest trees in this inventory.

Tree numbers 327 (Gary oak near rock creek park), 174 (library oak), 166 (downtown walnut) and #884 (Elementary school red oak) were larger than the other inventoried trees both back in 1984 and today. Tree #884 is the largest diameter tree measuring 56.8 inches diameter. This is very large If the trees were mostly new and small in the 1984 inventory, then these larger trees would likely not be much older than 70 years if we extrapolated the rate of growth back in time. A tree core analysis, historic photographs, or documentation on when Groper Park and rock creek drive were planted can help answer these questions and improve the data interpretation.
